A summary of a NIOSH fire fighter fatality investigation

March 11, 2009

Career Fire Captain Electrocuted After Contacting Overhead Powerline From the Platform of an Elevating Platform Fire Apparatus – Pennsylvania

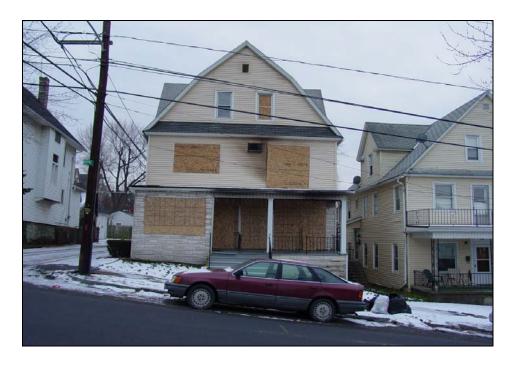
The fire building was a three-story residential house of wood frame construction that had been converted into three individual dwelling units, and was built sometime in the 1940's. The exterior consisted of aluminum siding, and asphalt shingles covered the roof. A three-phase 12,400-volt overhead powerline was located about 35-feet from the A-side of the structure and approximately 25-feet above ground level (see Photos 1 and 2).

Photo 1. Side-A of three story apartment building (incident scene). (NIOSH photograph.)

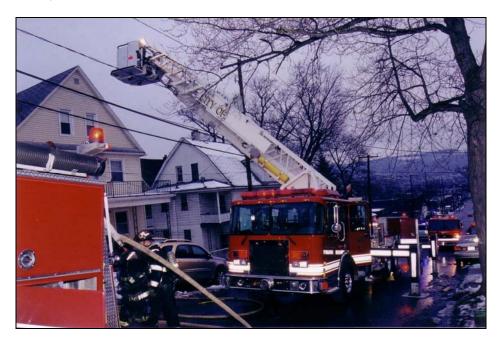
In this incident, a decision was made to ventilate the apartment building by using the elevating platform on T2 to gain access to the roof. T2 had been spotted in a position that required the aerial device to be maneuvered around a 12,400 volt powerline. Believing the powerlines had been deenergized the victim raised the elevating platform and extended it between the powerlines and communication lines. During this process, his neck and back came into contact with the energized powerline.

Photo 2. Truck 02 - 2002 model, 85-foot mid-mount, elevating platform. (Photograph taken shortly after the incident occurred by off duty fire fighter Bill Boock.)

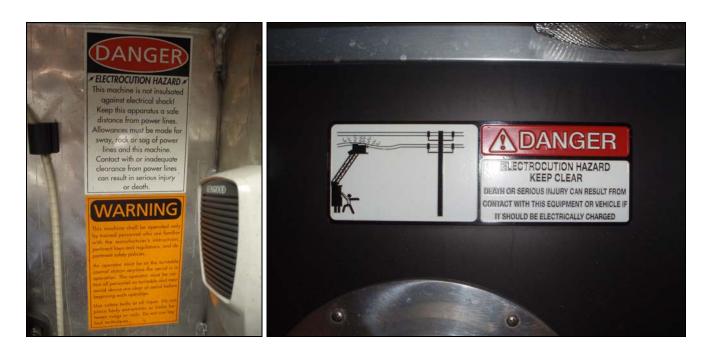
The apparatus involved in the incident (Truck 2) was a 2002 model, 85-foot mid-mount, elevating platform. Four warning signs were present on Truck 2. A sign was located on the turntable operator's controls cover and a similar sign was located on the back side of the platform. The signs stated – Danger -Electrocution Hazard - This machine is not insulated against electrical shock! Keep this apparatus a safe distance from power lines. Allowances must be made for sway, rock or sag of power lines and this machine. Contact with or inadequate clearance from power lines can result in serious injury or death. Also, a sign was located on the pump panel on both sides of the apparatus. The sign stated – Danger - Electrocution Hazard - Keep Clear – Death or serious injury can result from contact with this equipment or vehicle if it should be electrically charged. (See Photos 3 and 4).

Photos 3 and 4. Shown here are two of the four warning signs affixed to Truck 2.

Discussion: The following safety warning was printed in the manufacturer's "Trained Engineer's Manual" for operation of the elevating platform apparatus used at this incident: "Safety Warning! Avoid overhead electrical power lines! The aerial ladder is not insulated. If the ladder comes into close proximity/and or contacts any electrical power source, severe injury or death may occur to the Ladder Engineer, Ladder occupants, and possibly persons in close proximity to any part of the apparatus. Remember, the only safe power line is NO power line." In this incident, the fire department did not verify the utility company's report that the powerlines had been de-energized. Manufacturers' warnings for safe operation of equipment should always be followed.

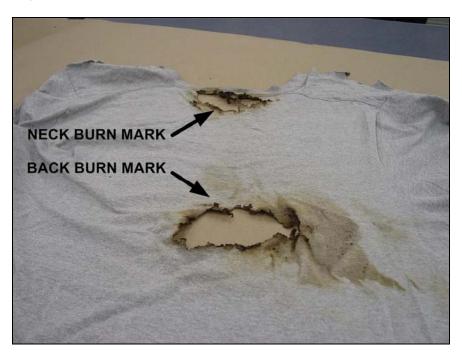
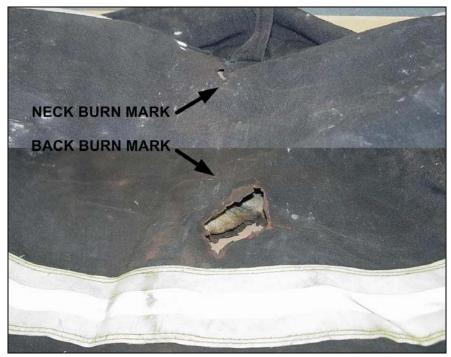
The victim instructed the fire fighter that they were going up in the platform. The victim retrieved a chain saw and he and the fire fighter climbed onto the platform of the elevating platform. Using the controls in the platform, the victim swung the platform out of its bed and toward the fire structure, and started extending the boom (see Photo 2). As the platform approached the overhead electrical wires, the fire fighter crouched down onto the platform and then heard an electrical arching (crackling) noise. The fire fighter looked up and saw a wire on the victim's back (see Photos 5 and 6). The arching stopped as the victim slumped down over the controls and fell back onto the platform.

Photos 5 and 6. Victim's T-shirt and bunker jacket with burn marks on the neck and back area from contact with the energized electrical powerline.

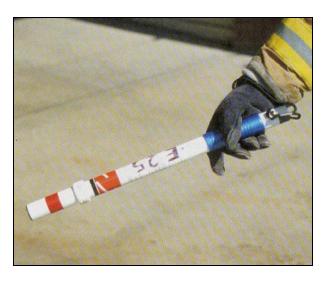
Photo 7. Alternating current detector. (Photograph courtesy of the International Fire Service Training Association.)

Discussion: Written standard operating guidelines (SOGs) or standard operating procedures (SOPs) enable individual fire department members an opportunity to read and maintain a level of assumed understanding of operational procedures. Fire departments can suffer when there is an absence of well developed SOGs or SOPs. The NIOSH Alert: "Preventing Injuries and Deaths of Fire Fighters" identifies the need to establish and follow fire fighting policies and procedures. Guidelines and procedures should be developed, fully implemented, and enforced to be effective. Periodic refresher training should be provided to assist fire fighters in remembering and understanding departmental guidelines and procedures. These SOGs or SOPs should include hazardous energy control procedures. The use of alternating current detectors to verify that powerlines are de-energized should be included in any hazardous energy control procedures developed by fire departments. *Note: Alternating current (AC) detectors can detect unshielded AC through snow, ice, and many solid objects. These battery-operated devices are handheld wands similar in size and shape to a police officer's baton. In the presence of an AC, they emit an intermittent beep. The more rapid the beep, the closer the source is. The detection range (distance from the source at which the wand detects the current) varies with the situation. In general, the higher the voltage, the greater the ranges will be² (see Photo 7).*

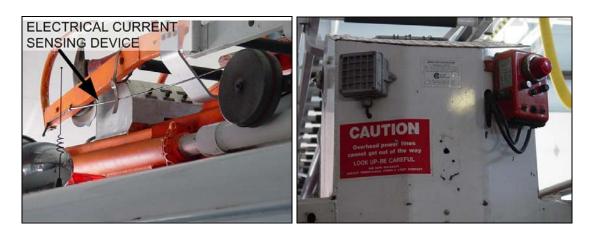
Photos 8 and 9. Example of proximity warning device used on aerial ladder truck at neighboring fire department. Photos left to right – electrical current sensing device, and alarm and control box.

Recommendation #5: Fire departments should use proximity warning devices to detect electrical current when working near exposed potentially energized parts (e.g. overhead powerlines) as a secondary/redundant means of protection.

Discussion: Proximity warning devices are used to detect the electrostatic field of any alternating current (AC) power line. They provide both audible and visual warning signals to alert the operator and attendant or ground personnel when the boom comes within the proximity of an energized high-voltage power line. These devices can help verify that lines are de-energized (see Photos 8, and 9).
